# The Straw-Tube Tracker of the ZEUS Detector at HERA

Stefan Goers

Physikalisches Institut, University of Bonn

IEEE – IMTC 2004, Como, Italy, 18-20 May 2004

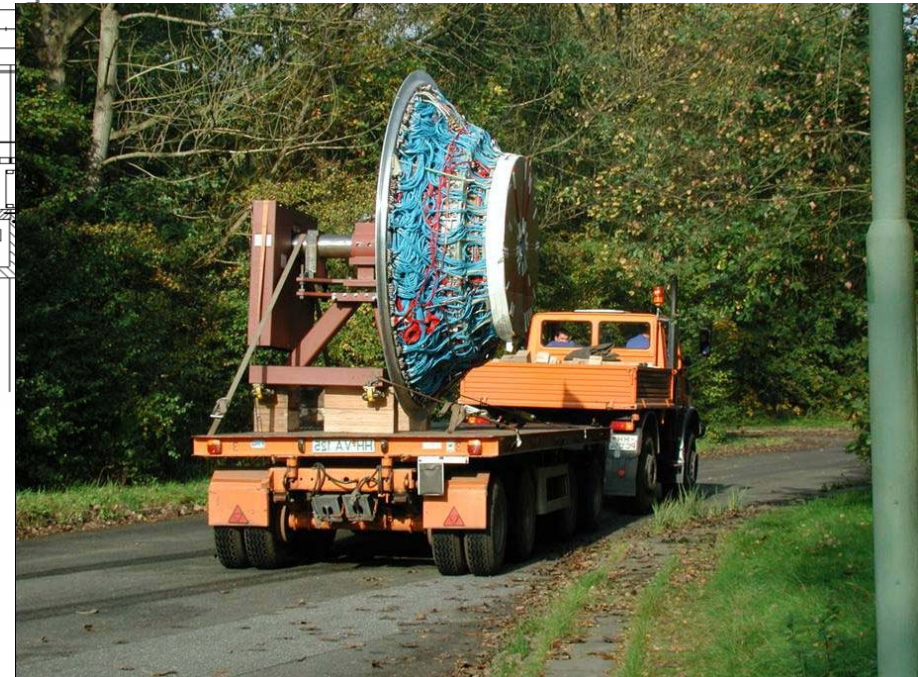
# Inner & Forward Tracking Detectors

Central tracking detector:

CTD for  $\theta > 25^\circ$

Forward tracking detectors:

STT+FTD for  $6^\circ < \theta < 25^\circ$

STT installed in 2001 shutdown

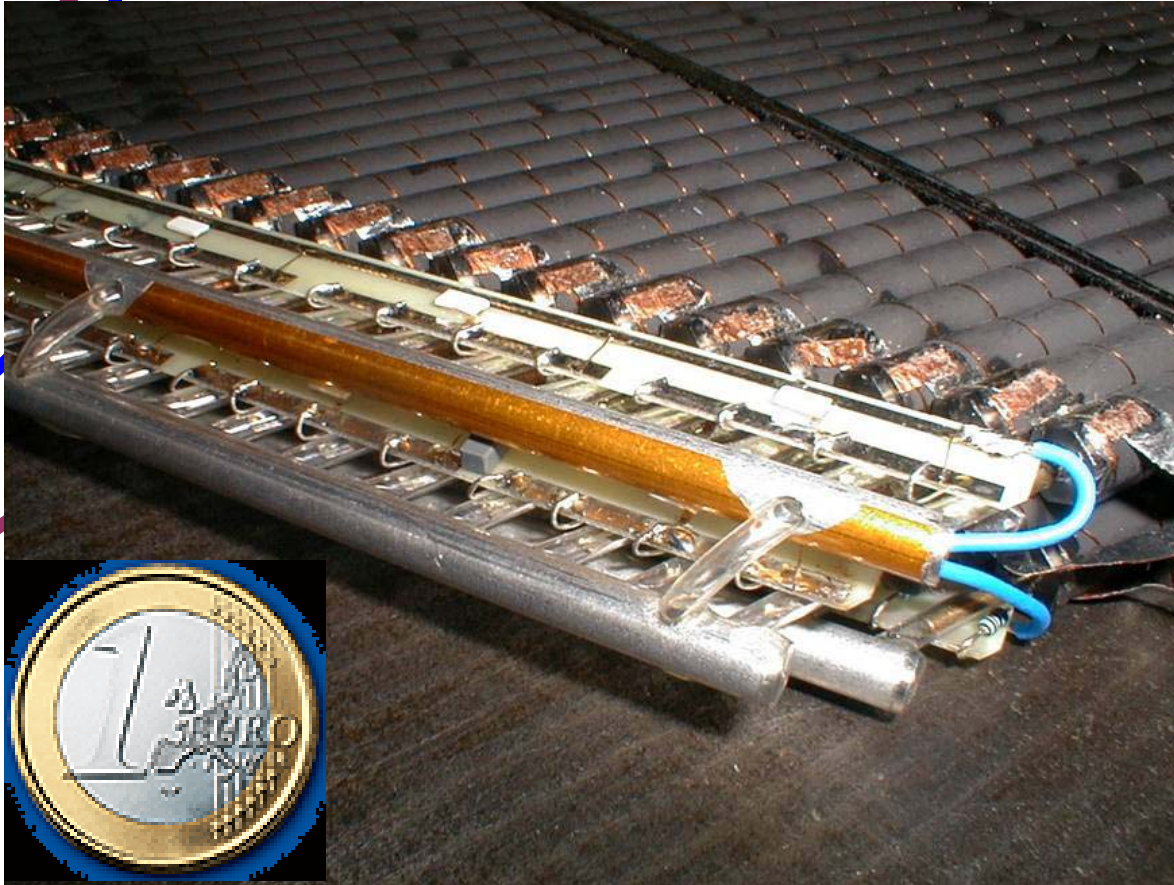
# The Straws

- Made of 2 layers of 50  $\mu\text{m}$  kapton foil
- Coated with
  - 0.2  $\mu\text{m}$  Al
  - 4  $\mu\text{m}$  C
  - 3-4  $\mu\text{m}$  polyurethane
- Cut into  $\approx 1\text{cm}$  strips
- Wound into 7.5 mm diameter straws
- Wire is 50  $\mu\text{m}$  Cu-Be
- Gas mixture:  
80% Ar / 20% CO<sub>2</sub>

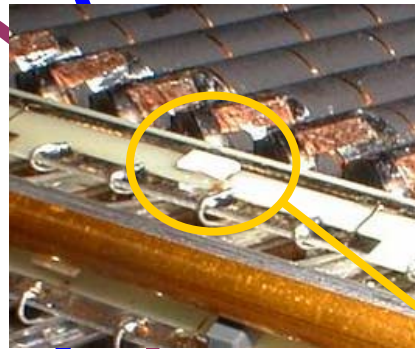
# The Straws – HV and HV fuses

Nominal HV: 1850V

Fuse works like a resistor (is a thin layer of metal)

- heat dissipation is possible up to a **current of  $\approx 1$  mA**
  - at higher currents the metal evaporates – „the fuse blows“
  - **resistivity goes from 100 kΩ to GΩ range**
- Does not blow when chamber trips due to bad background conditions

Experience: Fuses working, but a bit too fragile
